SUBSIDENCE HAZARDS AS A CONSEQUENCE OF DAM, RESERVOIR AND TUNNEL CONSTRUCTION

Petar MILANOVIC

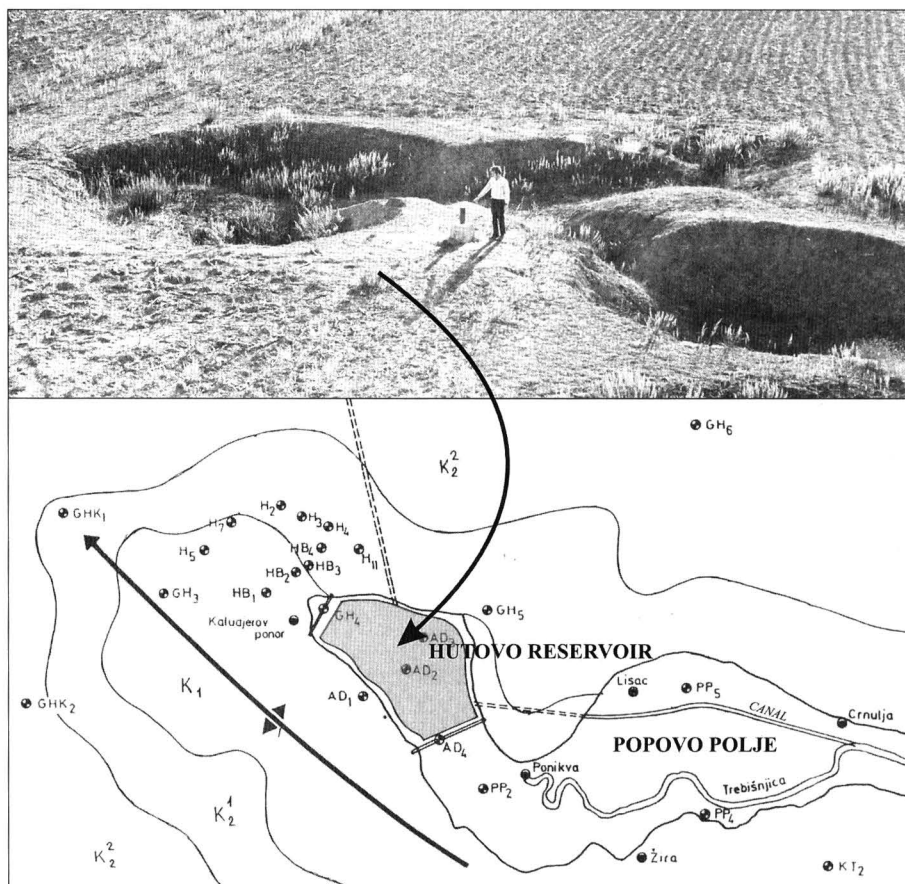
The reservoir area was losing water under natural conditions through 75 recorded ponors, represented by different sized subsidence. The largest was formed above the fossilized ponor of the river Trebisnjica (Fig. 2).

Fig. 2 - The main subsidence area in the Popovo Polje – Hutovo Reservoir.

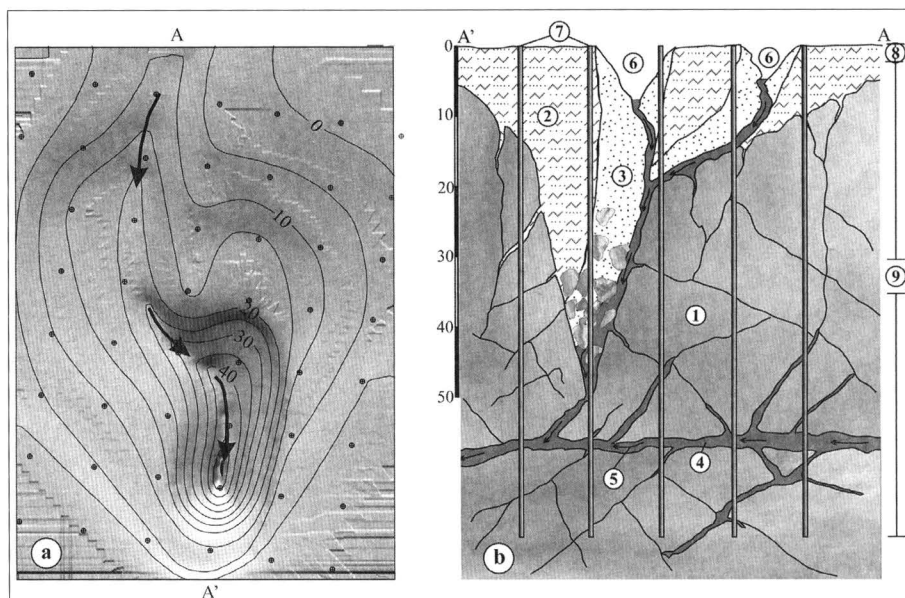
By applying different investigation methods (geological mapping, geophysical investigations and close spacing drilling) the fossilized opening of a ponor was detected at depth of 50 m beneath the floor level. Fig. 3 shows contour lines of paleo karst relief (a) and a cross-section (b) through the infilled karstic sinkhole with fossilized ponor at the very bottom. Presently, the swallowing capacity of the ponor is drastically limited.

Fig. 3 - Main subsidence – temporarily active ponor (Hutovo Reservoir): (a) = Contour lines of paleorelief and locations of investigation boreholes. Arrows indicate trace of fossil river bed toward the main ponor; (b) = Cross-section: 1 = Karstified limestone, 2 = Alluvial deposits; 3 = Degraded zone in alluvial deposits; 4 = Karst channel; 5 = Direction of underground flow; 6 = Subsidence; 7 = Investigation boreholes; 8 = Zone treated by compaction, and 9 = Zone treated by grouting.

The subsidence zone was rendered impermeable by grouting the karstified paleo-relief. Pressure grouting with a cement mixture was introduced from the surface. After grouting of the bedrock, the channels in the alluvial parts of the ponors were filled in with grout mix. A grouting mix with the approximate characteristics of the surrounding material (the proportion of clay was increased with respect to cement) was used.

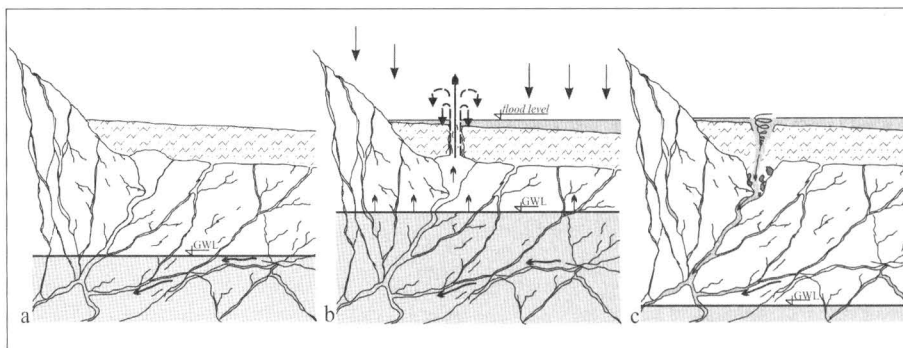
As a consequence, large volumes of air become trapped in some caverns, as shown in Fig. 4a. This air does not have time to escape, because the surface layer of soil is rapidly saturated with water. Therefore, air becomes entrapped and pressurized (Fig.4b). When the pressure exceeds the strength of the overlying alluvial layers, air

eruption destroys this zone. At the surface this has been observed as fountain-like eruptions. After water table depression beneath the area of destroyed sediments, water sinks through newly created ponors (c).

Fig. 4 - Subsidence created by air-hammer effects

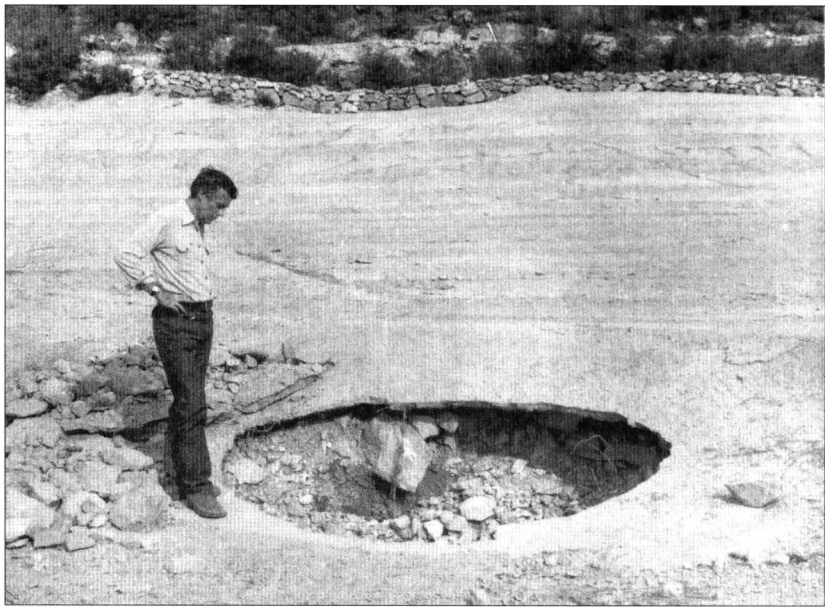
In some cases reinforced shotcrete is not sufficiently resistant against strong uplift pressures (Fig. 5).

Fig. 5 - Subsidence created in a shotcrete protective layer by strong groundwater uplift.

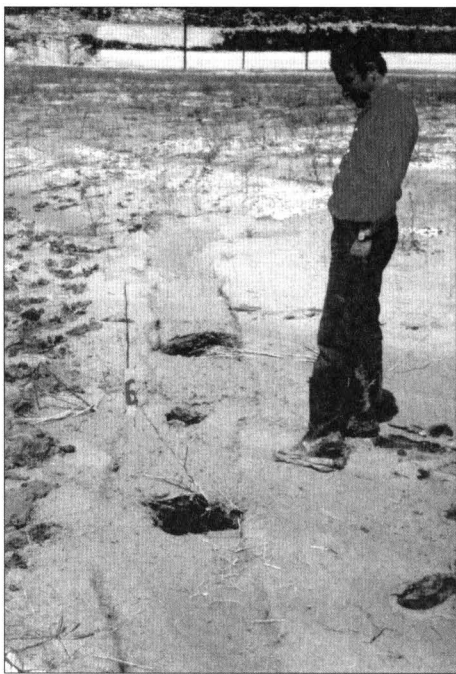
section. In some cases subsidences developed between two parallel cracks (Fig. 7).

Fig. 7 - Subsidence developed between two parallel cracks.

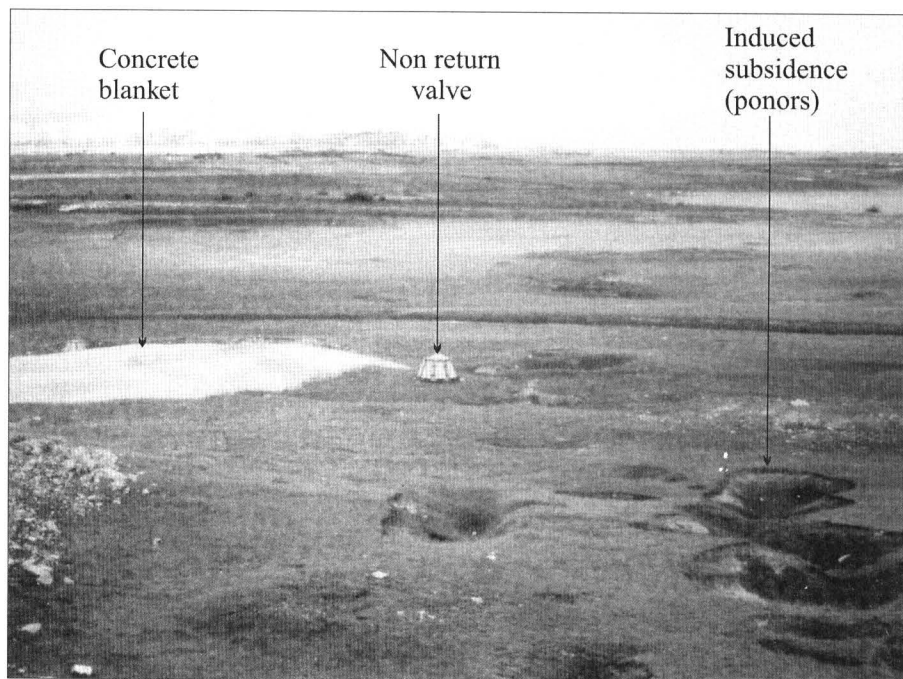
A particular problem is presented in the case of estavelles in the storage reservoirs. Because of its double hydrogeological function every estavelle is a potential subsidence site. In order to improve the water-tightness of Vrtac reservoir in Niksic Polje, Yugoslavia, several sealing methods were applied (cylindrical dams, plugging of ponors, non-return valves and concrete blankets). Unfortunately, all these measures were unsuccessful. After the first reservoir filling and a strong water table rise during the wet season, the groundwater could not discharge through the natural estavelle openings. As a consequence more than 100 new subsidences were formed in the reservoir floor (Fig. 8).

Fig. 8 - Niksic Polje. Subsidence induced by reservoir operation.

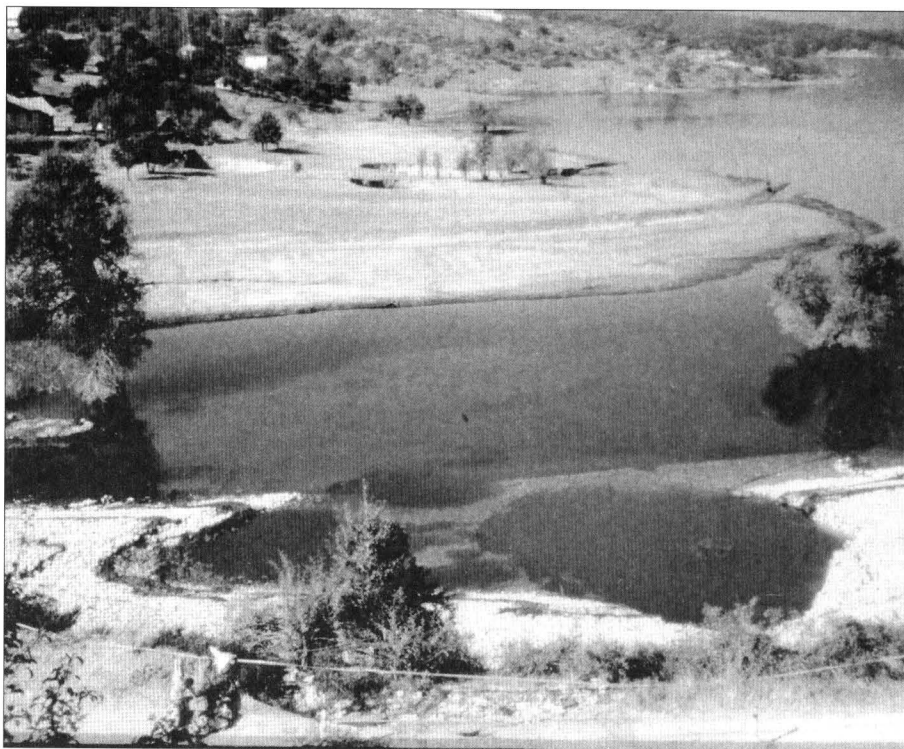
fill sediments, finally creating erosion channels in the alluvial cover. During the very rainy year of 1986, abrupt water level increase served as a trigger to development of subsidences (Fig. 9).

Some of the subsidences were formed within the blanket zone, but more of them developed in the natural deluvial cover overlying the marbleized limestone. These subsidences provoked considerable environmental impact in the form of heavy damage to local roads and surrounding houses. A wide range of geological and geophysical investigations have been carried out to determine the actual conditions, to ensure selection of an appropriate impermeability treatment. Finally, the subsidence (ponor) zone was isolated from the reservoir by construction of an earth filled dyke.

Fig. 9 - Mavrovo Reservoir. Subsidence induced by reservoir operation.

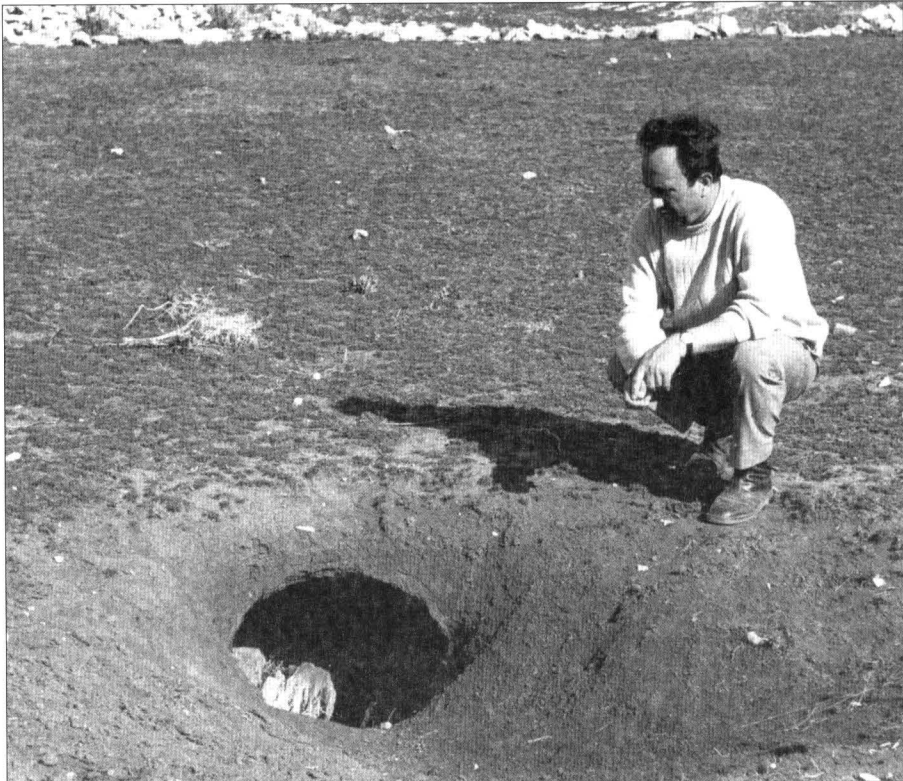
In some cases subsidence development is not a consequence of groundwater filtration out of a reservoir. It occurs as a consequence of frequent and high amplitude fluctuation in deep reservoirs, particularly if the amplitudes are more than 50 m. Intensive, but local, suffosion processes between the upper and lower parts of the same bank of the Bileca reservoir (Herzegovina) provoked a few subsidences in the upper section (Fig. 10).

Fig. 10 - Bileca Reservoir. Subsidence created by local water filtration.

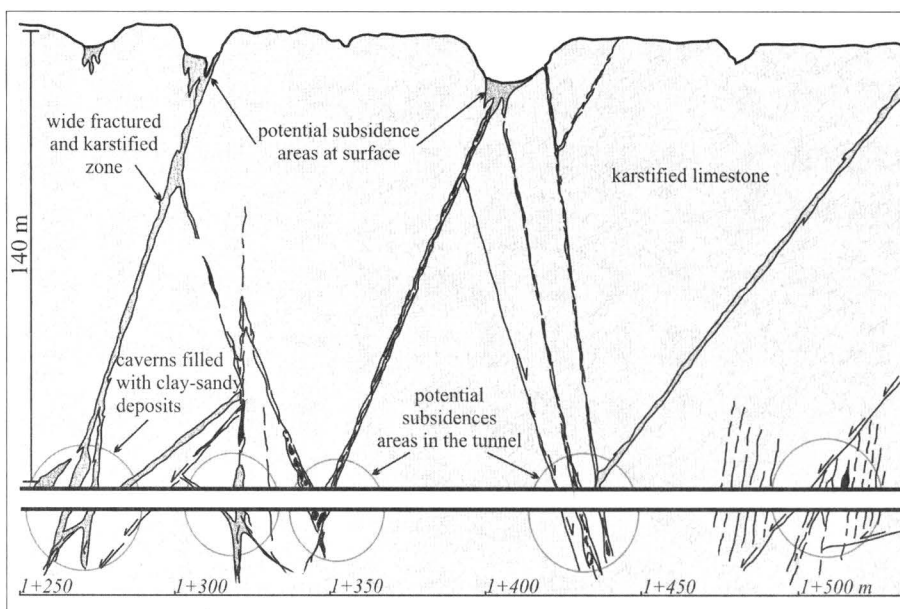
Defects encountered during underground excavations and tunnelling operation in karst can provoke undesirable effects at the surface. Any fault or cavernous zone that connects a tunnel section with the surface holds potential for subsidence, especially in the case of thin overburden (Fig. 11). The collapse prone areas are particularly susceptible in the case of hydrotechnical tunnels, especially derivation high-pressure tunnels.

Fig. 11 - The Dabar - Fatnica Tunnel. Potential subsidence zones.

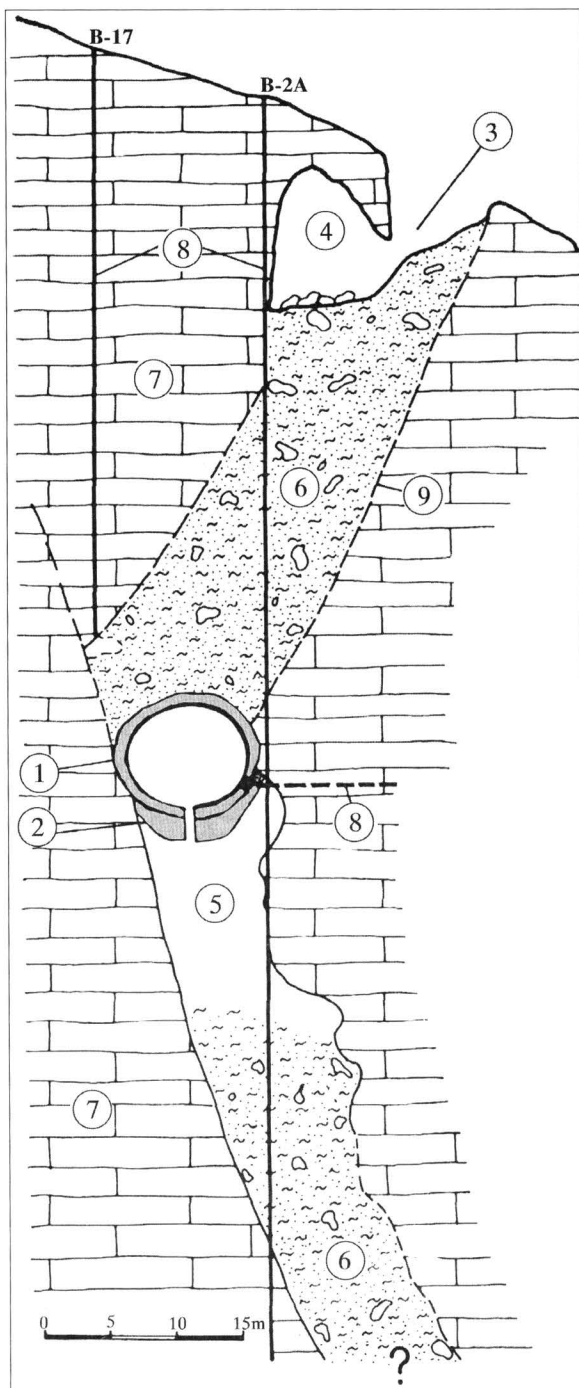
Subsidences created during tunnelling operations are illustrated by the following example. Water leakage from a headrace tunnel tube eroded and washed away unconsolidated cave deposits in the section where the tunnel intersected a large filled cavern (Fig. 12).

Percolation through the tunnel lining caused intensive erosion and transport of great volumes of sandy-clay cave deposits toward deeper channel sections over time. This resulted in the development of an empty space around the tunnel tube, and formation of subsidence at the surface. Particularly dangerous was the washed-out part of the cavern situated below the lining, with a length of 16 m, a width of about 7 m and a depth of 8 to 15 m. The loss of support seriously endangered the stability of the tunnel tube.

Fig. 12 - Headrace tunnel for HPP Capljina. Subsidence as a consequence of tunnelling operations: 1 = Tunnel lining; 2 = Part of lining additionally reinforced; 3 = Collapse; 4 = Cave origin as a consequence of collapse; 5 = Empty cavernous space below tunnel tube; 6 = Cave deposits (clay, sand, and limestone blocks); 7 = Limestone; 8 = Borehole; 9 = Fault.

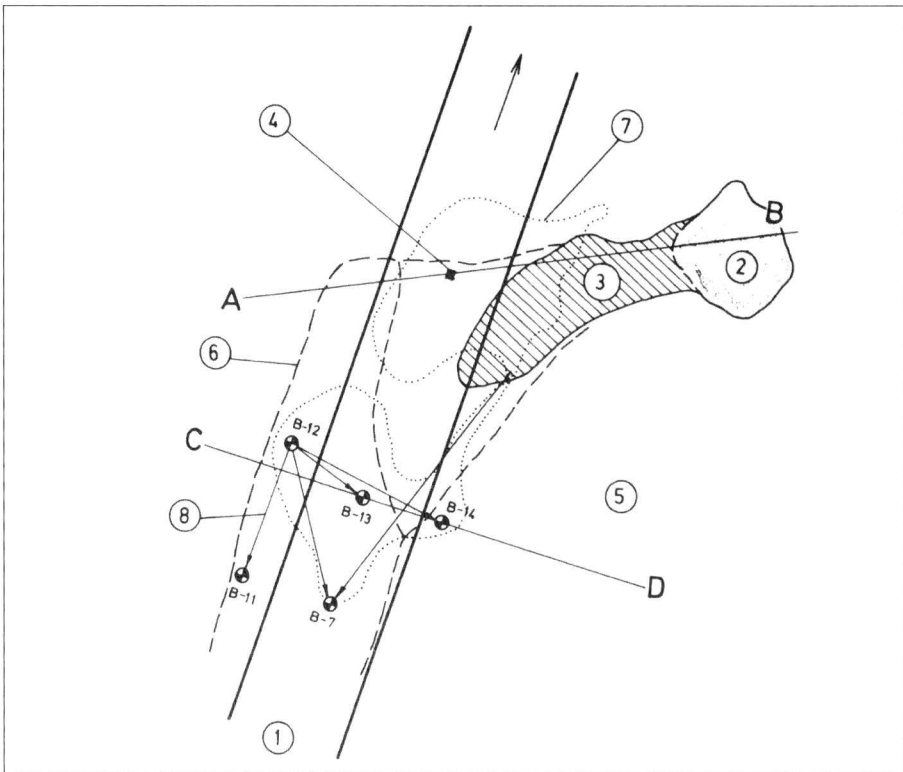
Complex investigation work has been carried out, including drilling, water level monitoring, measurements of leakage, geological analysis, speleological investigations, TV logging and tracing tests by dye and smoke tracers (Fig. 13). Speleological investigations, including detailed mapping of surface subsidence and underground collapse, were very successful.

Fig. 13 - Headrace tunnel for HPP Capljina. Cavern contours.

1 = Tunnel; 2 = Subsidence; 3 = Cavern, originated as a consequence of subsidence; 4 = Shaft cut through the lined invert; 5 = Limestone; 6 = Cavern contour line below the tunnel lining; 7 = Cavern contour line above the tunnel tube; and 8 = Connection established by smoke tracer.
